L1970450003 – Will  
Carlstrom Landfill  
ILD 980497721  
SF/HRS

**CERCLA  
EXPANDED SITE INSPECTION REPORT**

**Carlstrom Landfill**

**September 9, 2004**

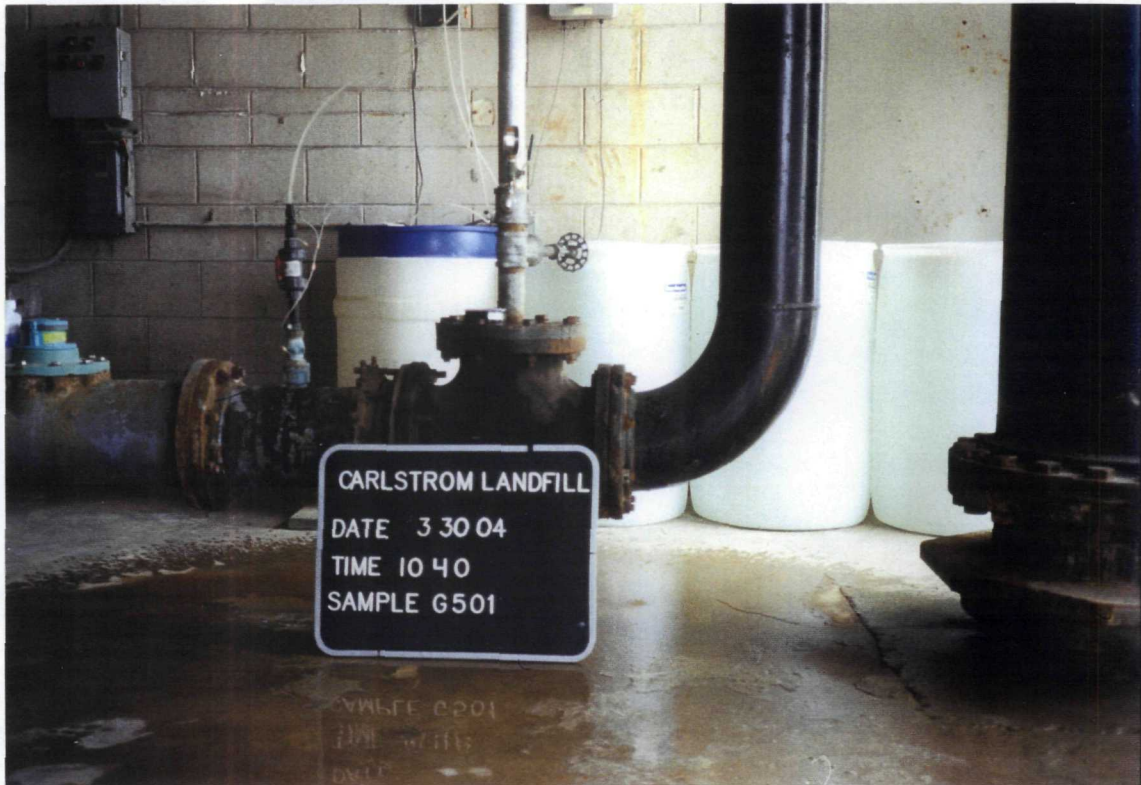
DATE: 3/30/04	SITE ILD#: 980497721	COUNTY: Will
TIME: 10:40	SITE NAME: Carlstrom Landfill	
PHOTOGRAPH TAKEN BY: R. Casper		
COMMENTS: Picture taken toward: South.		
Photo Number 1.		
Sample G501 was collected from a Joliet municipal well located 2,000 feet northeast.

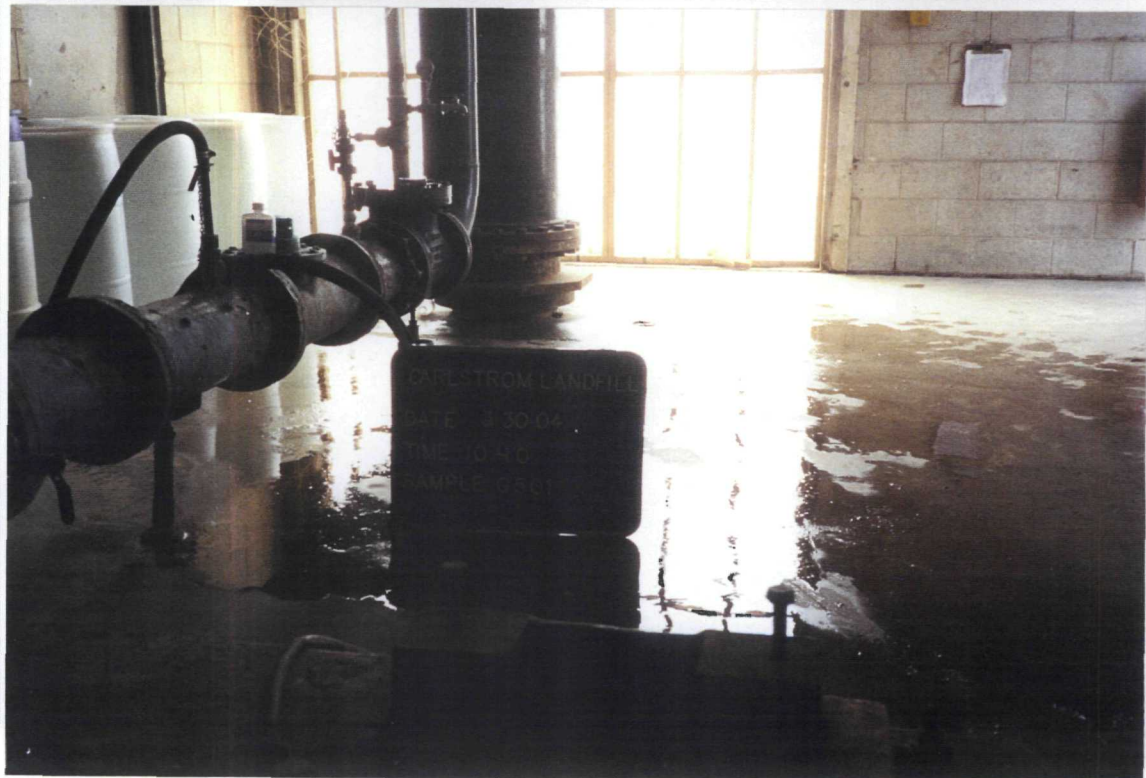
DATE: 3/30/04
TIME: 10:40
PHOTOGRAPH TAKEN BY: R. CASPER
COMMENTS: Picture taken toward: West.
Photo Number 2.
Sample G501. The well is approximately 1,565 feet deep.

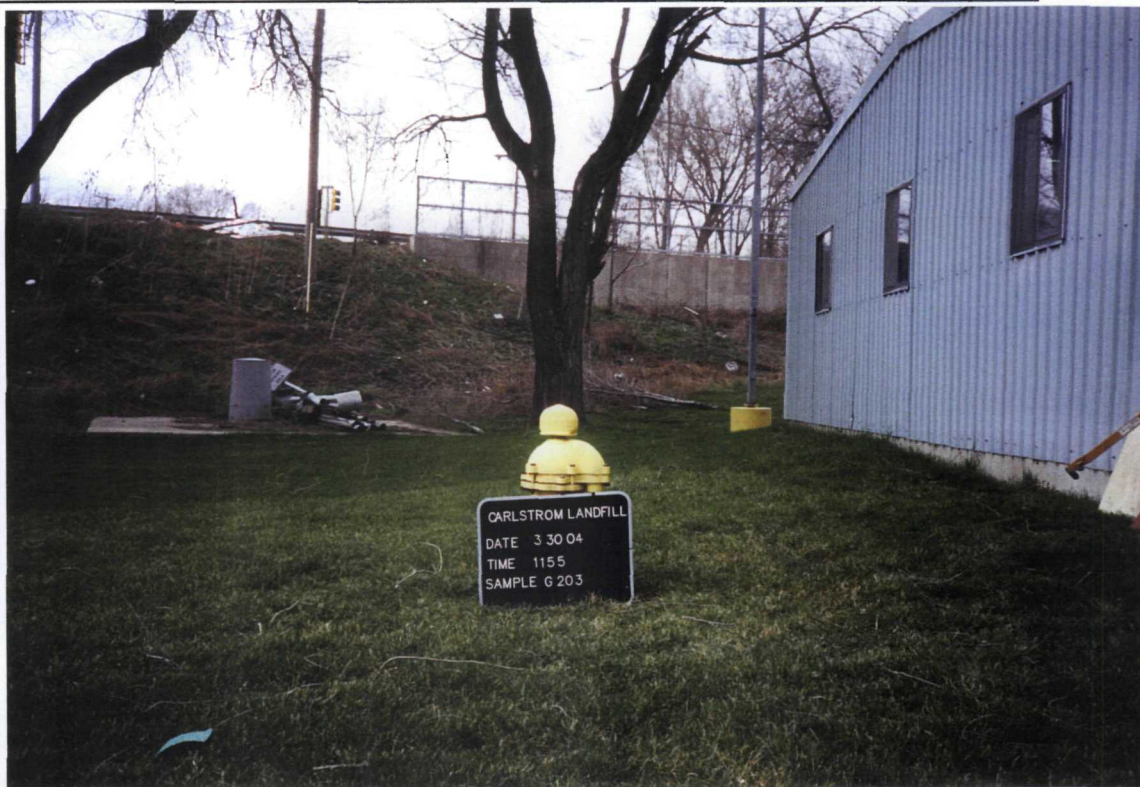
DATE: 3/30/04	SITE IL# #: 980497721	COUNTY: Will
TIME: 11:55	SITE NAME: Carlstrom Landfill	
PHOTOGRAPH TAKEN BY: R. Casper		
COMMENTS: Picture taken toward: North.		
Photo Number 3.		
Sample G203 was collected from a well located near Brandon locks.

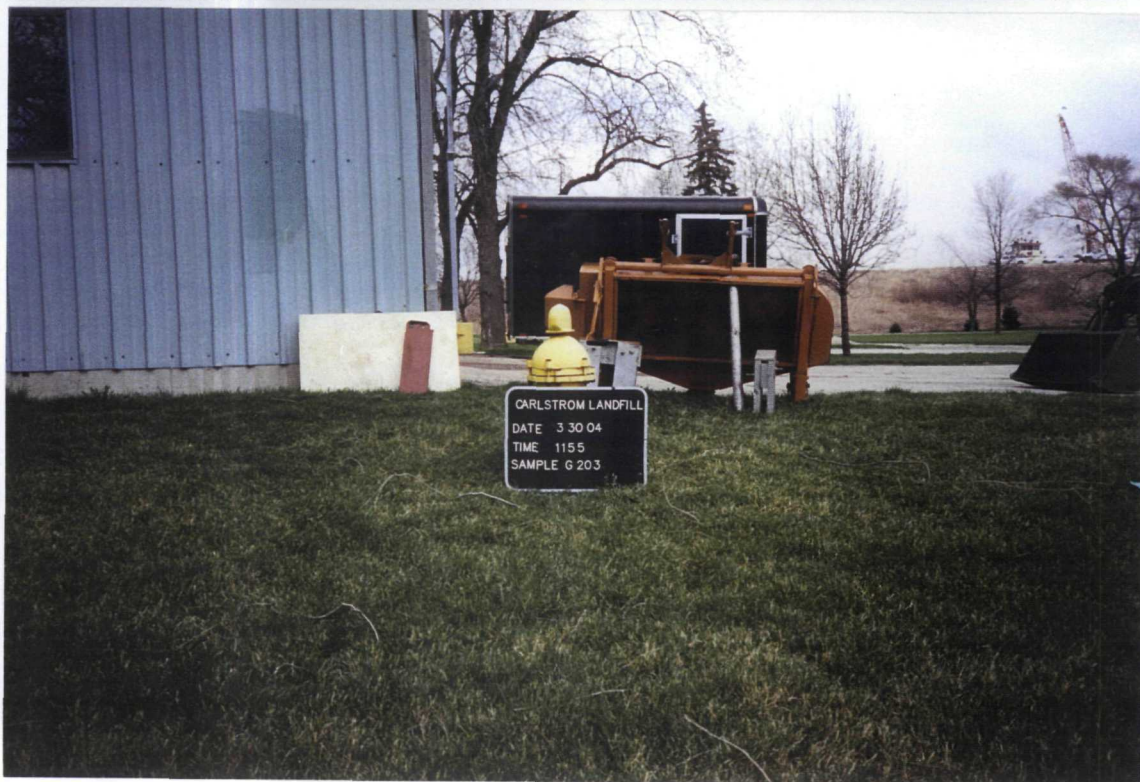
DATE: 3/30/04
TIME: 11:55
PHOTOGRAPH TAKEN BY: R. CASPER
COMMENTS: Picture taken toward: East.
Photo Number 4.
Sample G203. The well pump is set at 675 feet, and is located approximately 3,000 feet southwest of site.

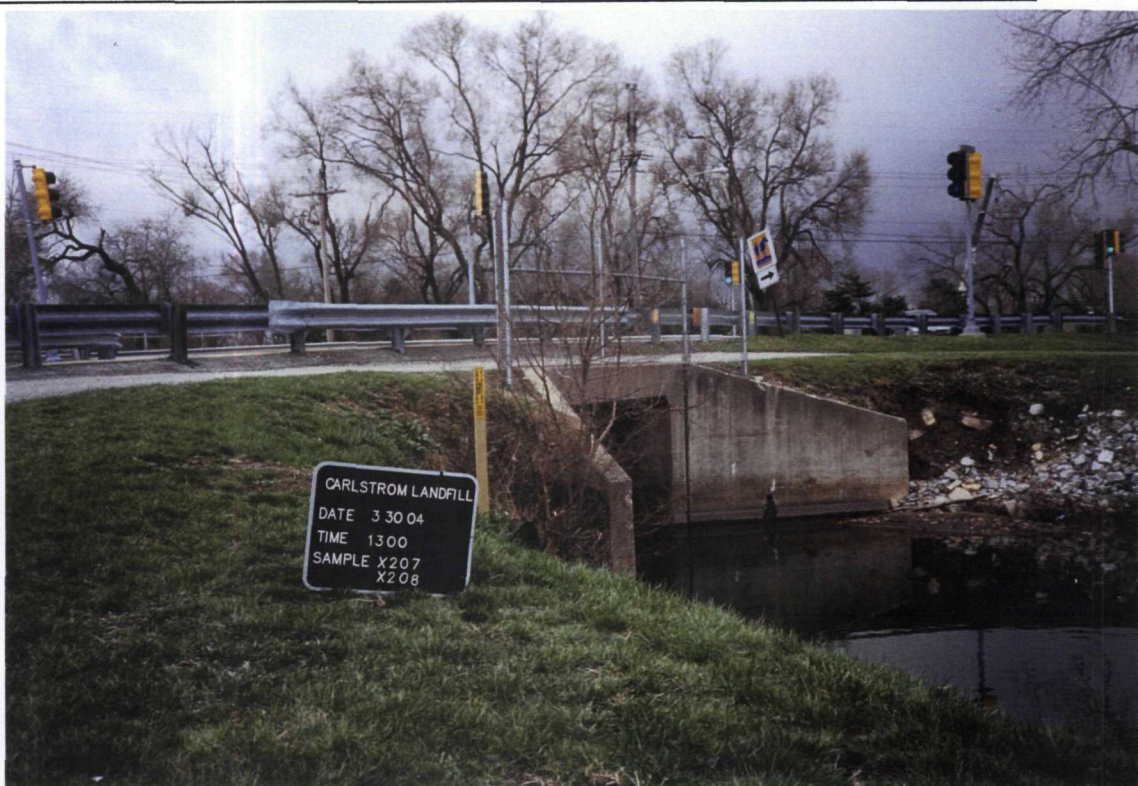
DATE: 3/30/04	SITE IL# #: 980497721	COUNTY: Will
TIME: 13:00	SITE NAME: Carlstrom Landfill	
PHOTOGRAPH TAKEN BY: R. Casper		
COMMENTS: Picture taken toward: East.		
Photo Number 5.		
Samples X207/X208		
are duplicate		
sediment samples		
collected from the		
I & M canal.

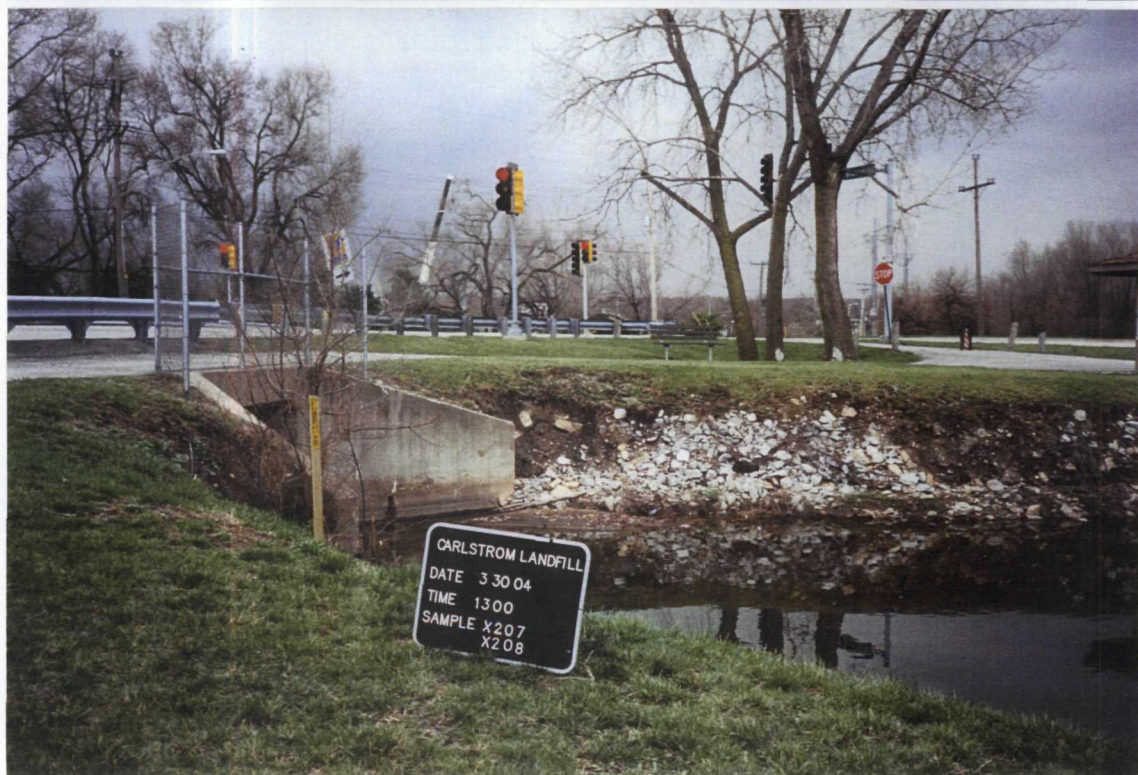
DATE: 3/30/04
TIME: 11:55
PHOTOGRAPH TAKEN BY: R. CASPER
COMMENTS: Picture taken toward: South.
Photo Number 6.
Samples X207/X208
were collected at
a depth of 0 to 10
inches approximate-
ly 3,000 feet
southwest of site.

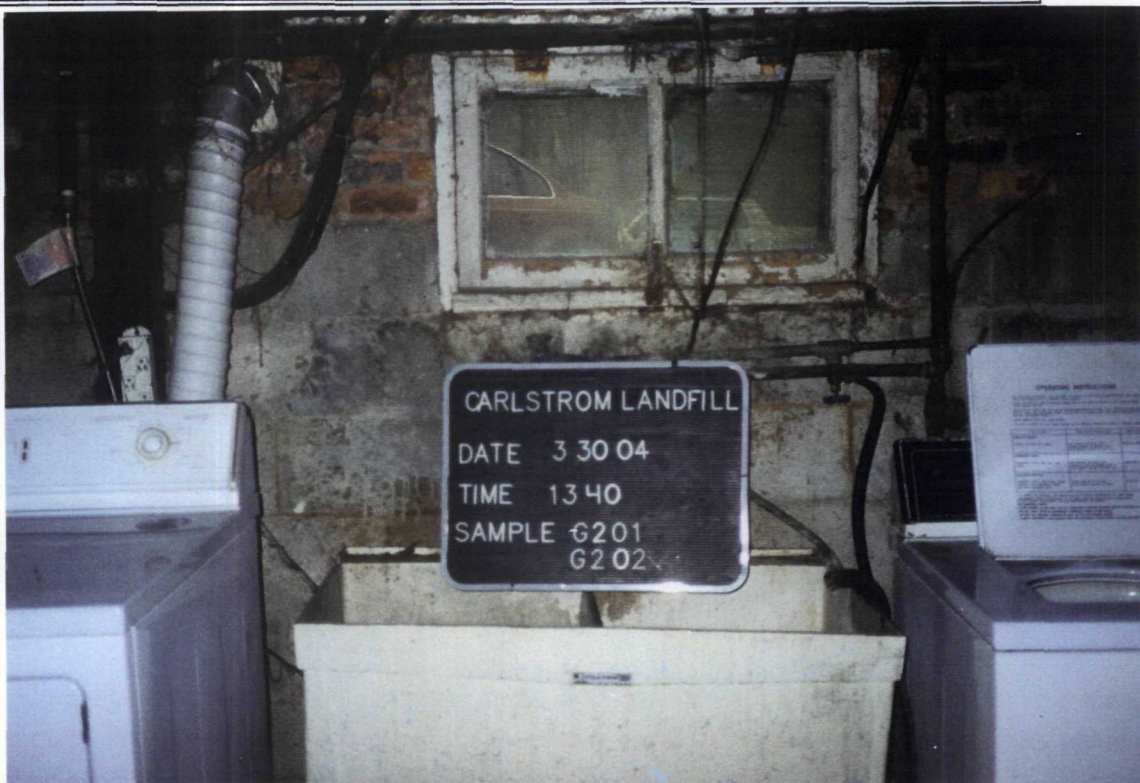
DATE: 3/30/04	SITE ILID#: 980497721	COUNTY: Will
TIME: 13:40	SITE NAME: Carlstrom Landfill	
PHOTOGRAPH TAKEN BY: R. Casper		
COMMENTS: Picture taken toward: East.		
Photo Number 7.		
Samples G201/G202		
were collected from		
a private well lo-		
cated approximately		
2,600' SW of site.

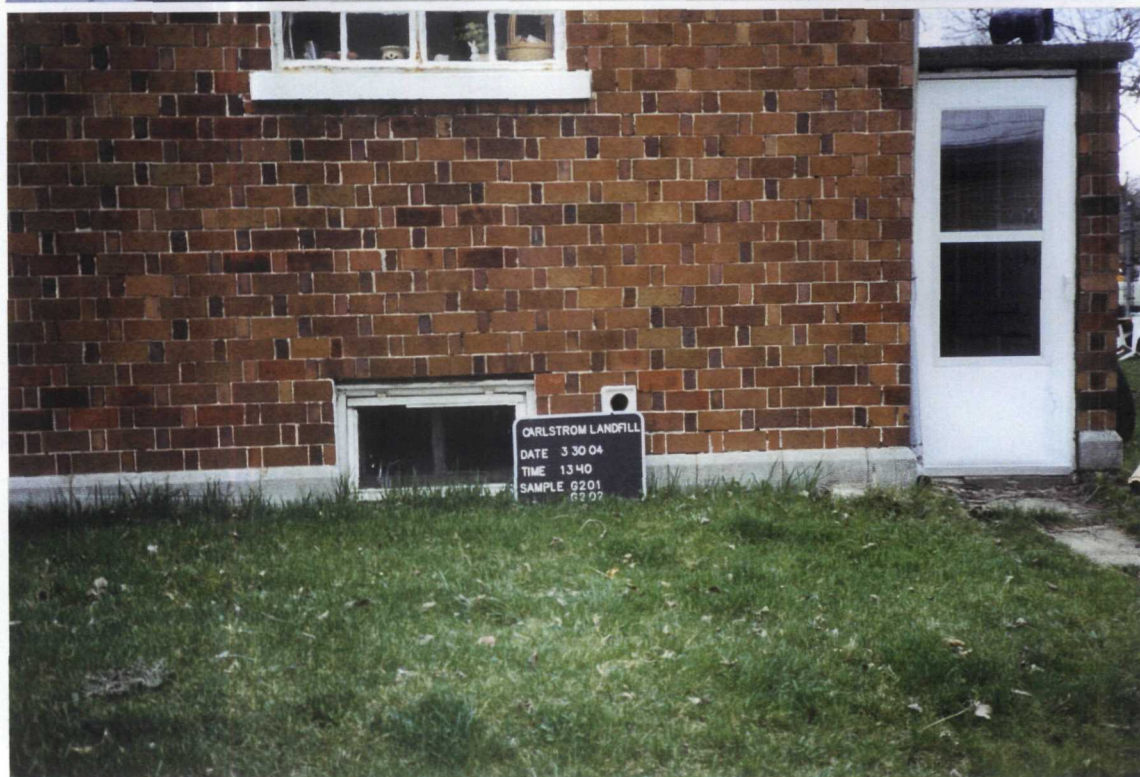
DATE: 3/30/04
TIME: 13:40
PHOTOGRAPH TAKEN BY: R. CASPER
COMMENTS: Picture taken toward: West.
Photo Number 8.
Sample G203. The
well is reported
to be only 31 feet
deep and sometimes
acts as an artesian
well.

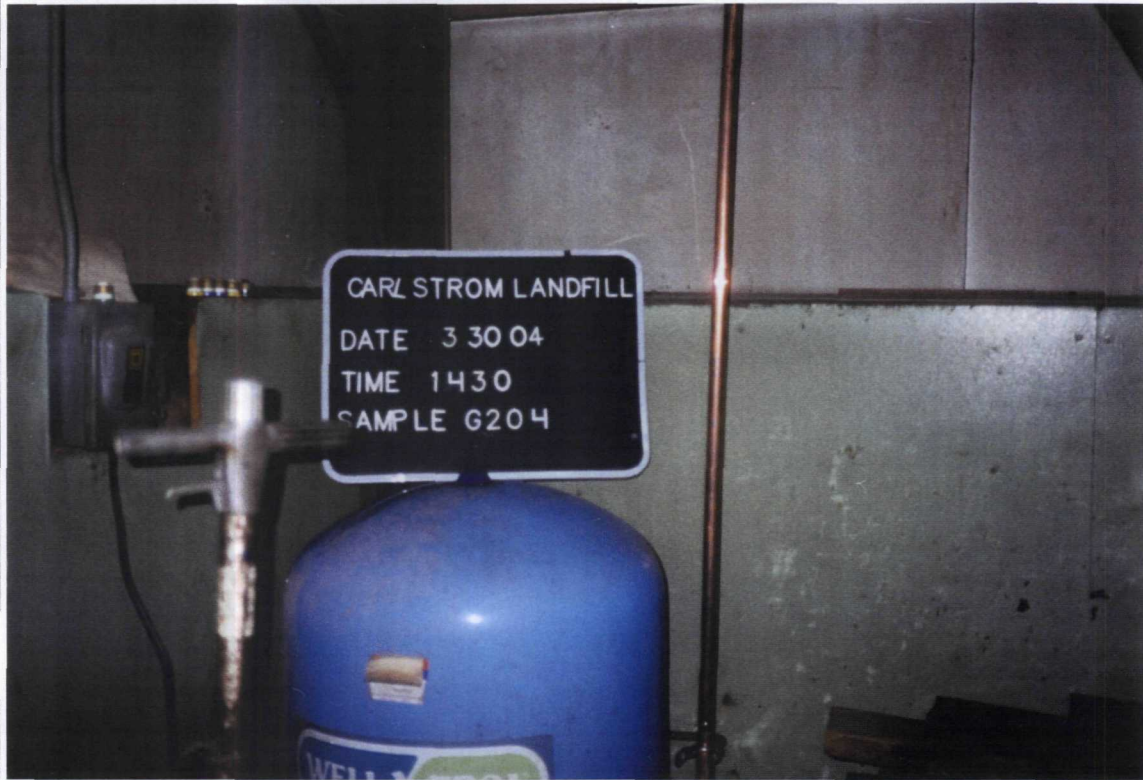
DATE: 3/30/04	SITE ILD#: 980497721	COUNTY: Will
TIME: 14:30	SITE NAME: Carlstrom Landfill	
PHOTOGRAPH TAKEN BY: R. Casper		
COMMENTS: Picture taken toward: South.		
Photo Number 9.		
Sample G204 was collected from a private well located approximately 1,800' SW of site.

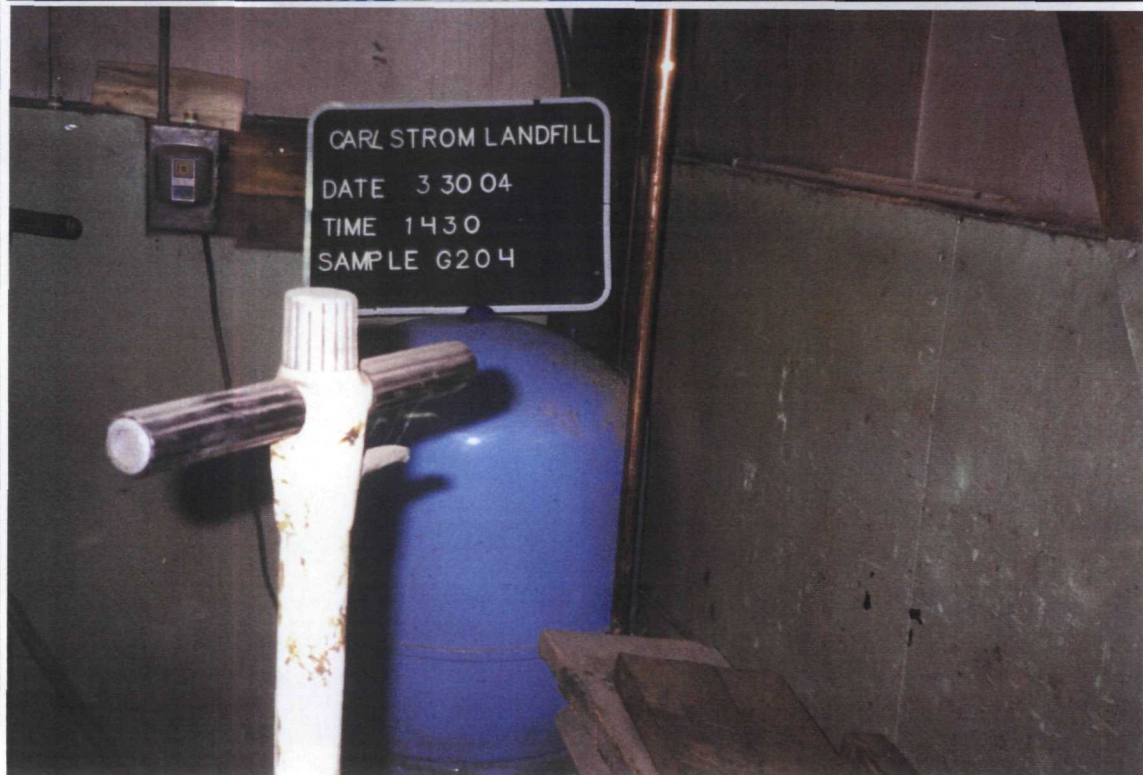
DATE: 3/30/04
TIME: 14:30
PHOTOGRAPH TAKEN BY: R. CASPER
COMMENTS: Picture taken toward: East.
Photo Number 10.
Sample G204. The well pump is located inside a large metal building used for business.

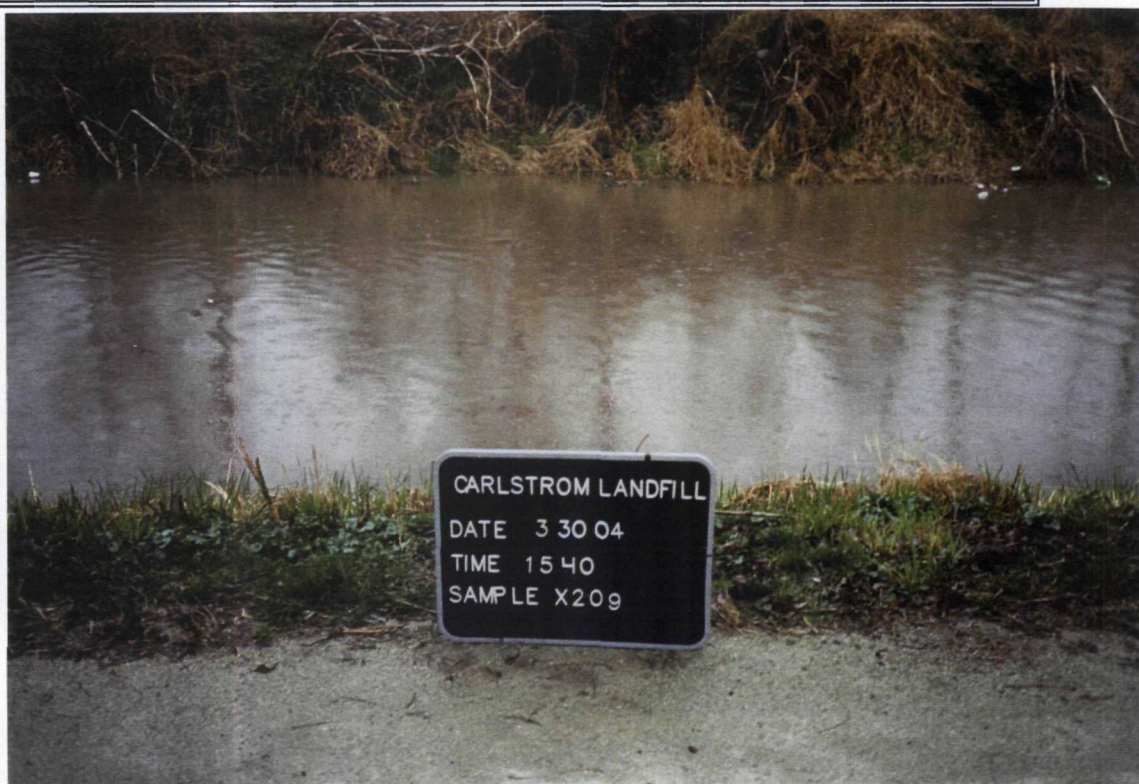
DATE: 3/30/04	SITE ILD#: 980497721	COUNTY: Will
TIME: 15:40	SITE NAME: Carlstrom Landfill	
PHOTOGRAPH TAKEN BY: R. Casper		
COMMENTS: Picture taken toward: North.		
Photo Number 11.		
Sample X209 was collected from the south side of the I & M canal at a depth of 0" to 12"

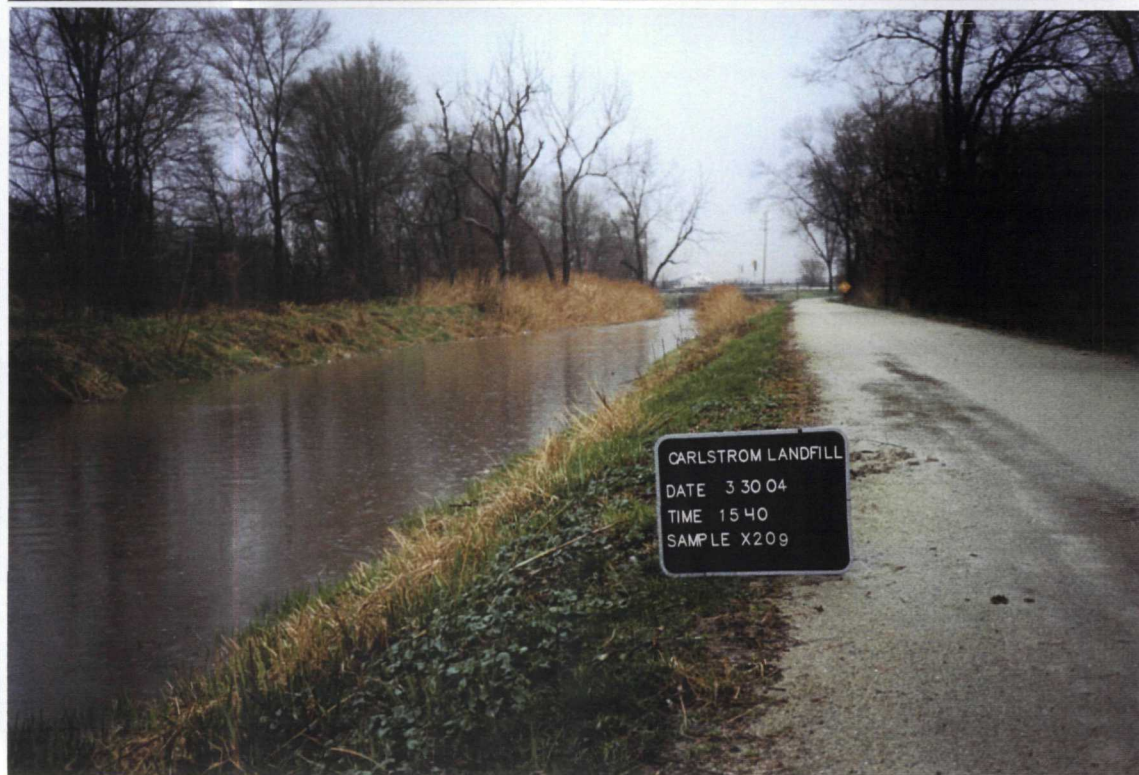
DATE: 3/30/04
TIME: 15:40
PHOTOGRAPH TAKEN BY: R. CASPER
COMMENTS: Picture taken toward: East.
Photo Number 12.
Sample X209. The sample was collect-
ed approximately
350 feet west of
Brandon Road.

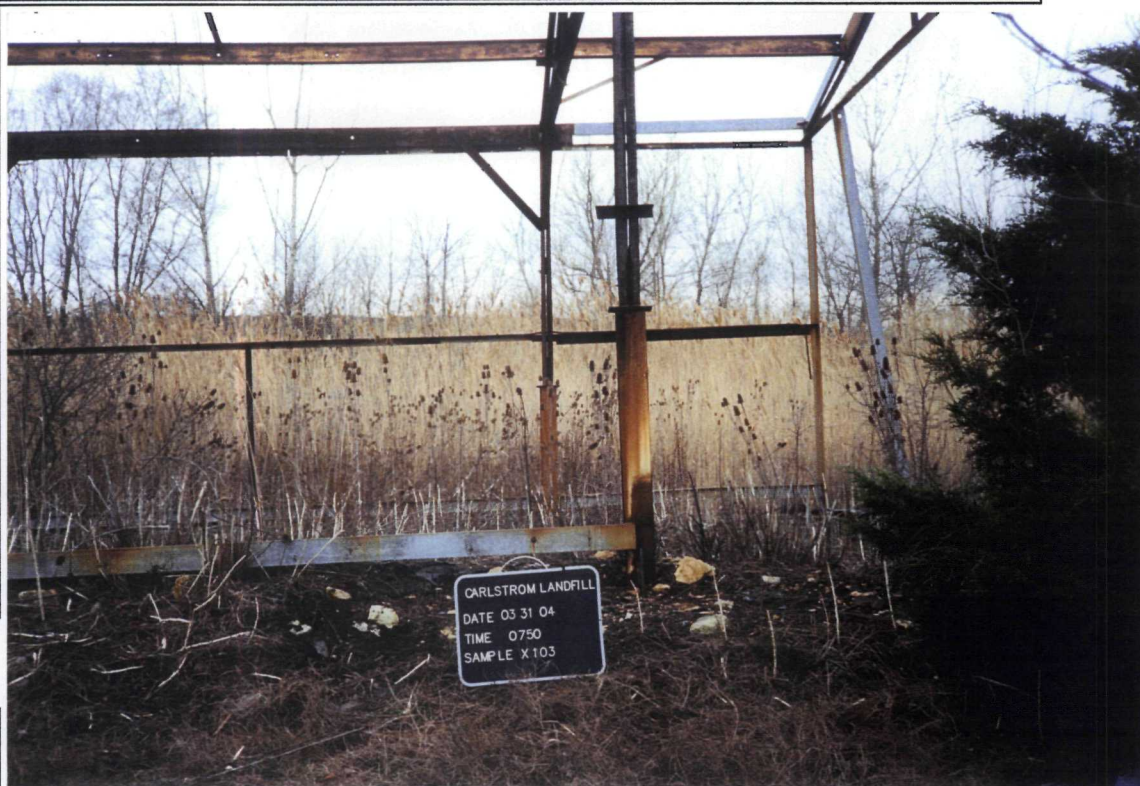
PHOTOGRAPH TAKEN BY: R. Casper
COMMENTS: Picture taken toward: North.
Photo Number 13.
Sample X103 was collected near the southeast corner of an old metal building frame.

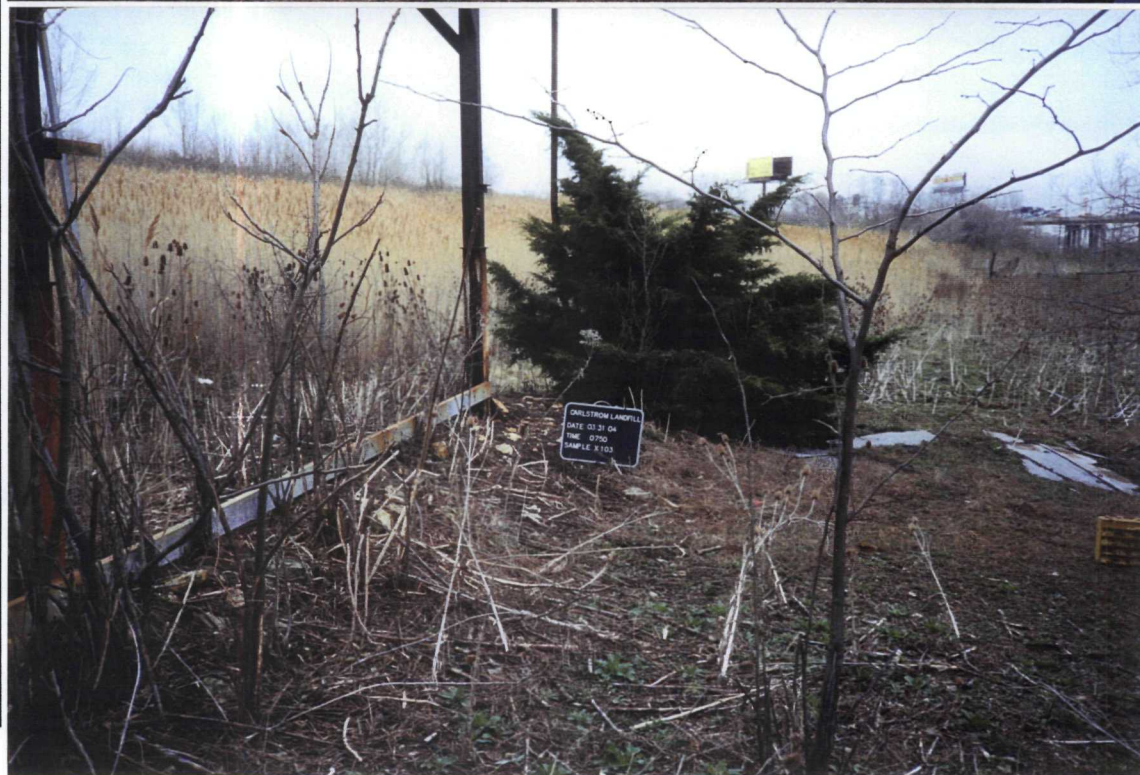
DATE: 3/31/04
TIME: 7:50
PHOTOGRAPH TAKEN BY: R. CASPER
COMMENTS: Picture taken toward: East.
Photo Number 14.
Sample X103. The sample was collect- ed at a depth of 3" to 9".

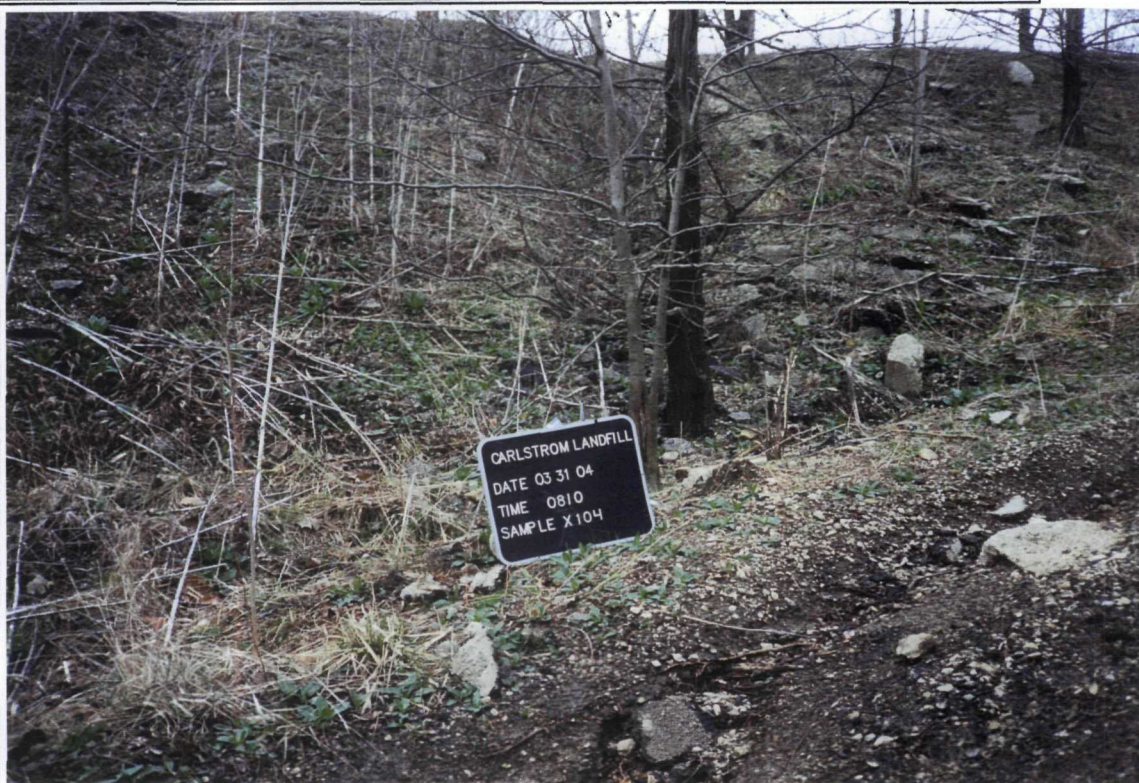
PHOTOGRAPH TAKEN BY: R. Casper
COMMENTS: Picture taken toward: North.
Photo Number 15.
Sample X104 was collected at the western portion of landfill near the base.

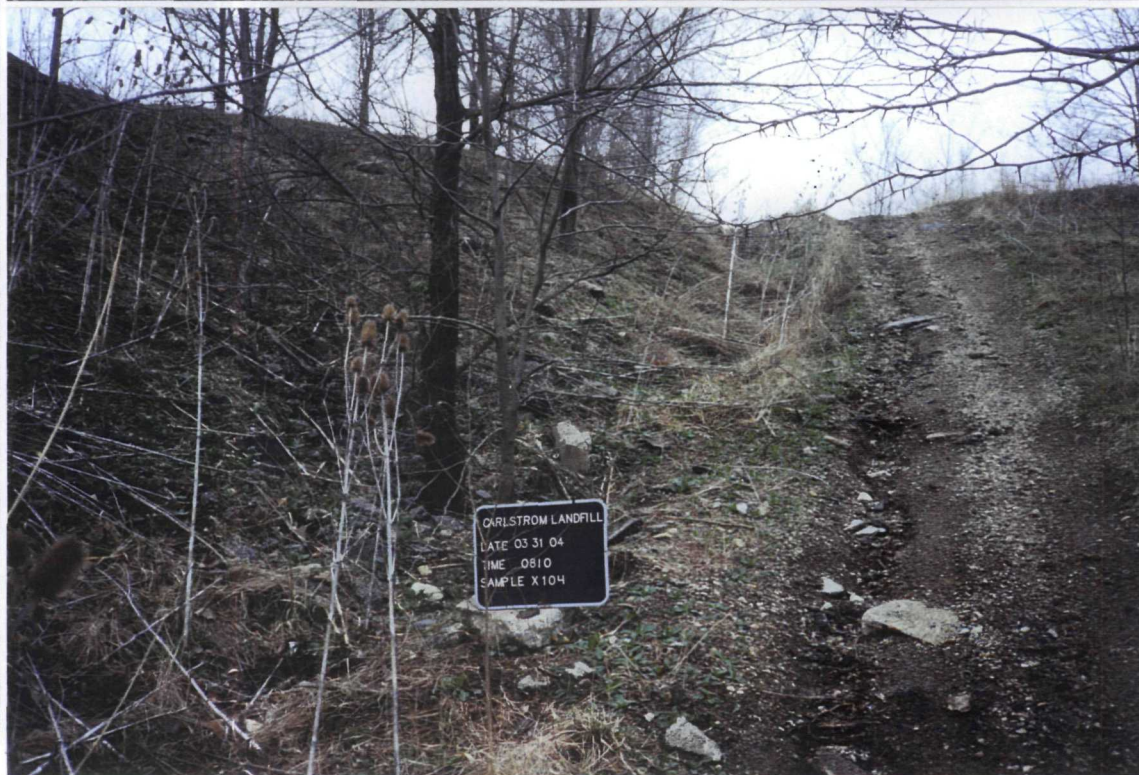
DATE: 3/31/04
TIME: 8:10
PHOTOGRAPH TAKEN BY: R. CASPER
COMMENTS: Picture taken toward: East.
Photo Number 16.
Sample X104. The sample was collect- ed at a depth of 0" to 6" in a small ravine.

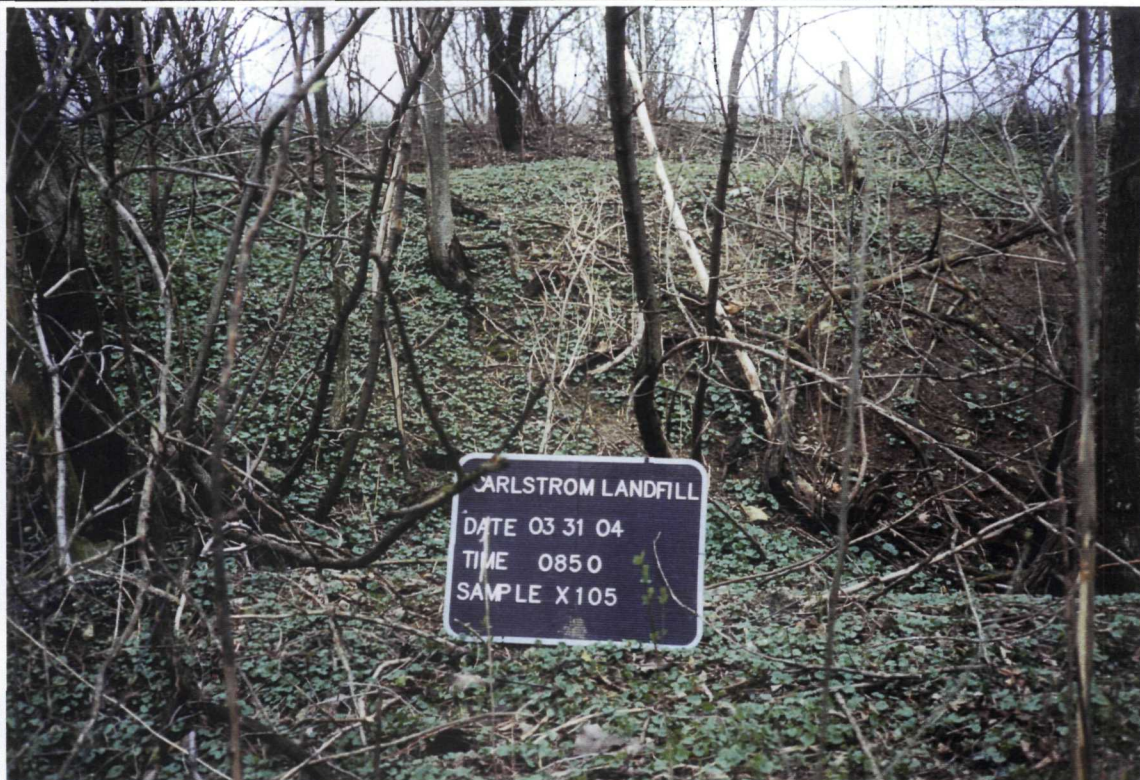
PHOTOGRAPH TAKEN BY: R. Casper
COMMENTS: Picture taken toward: North.
Photo Number 17.
Sample X105 was collected at the northern portion of the landfill near the base.

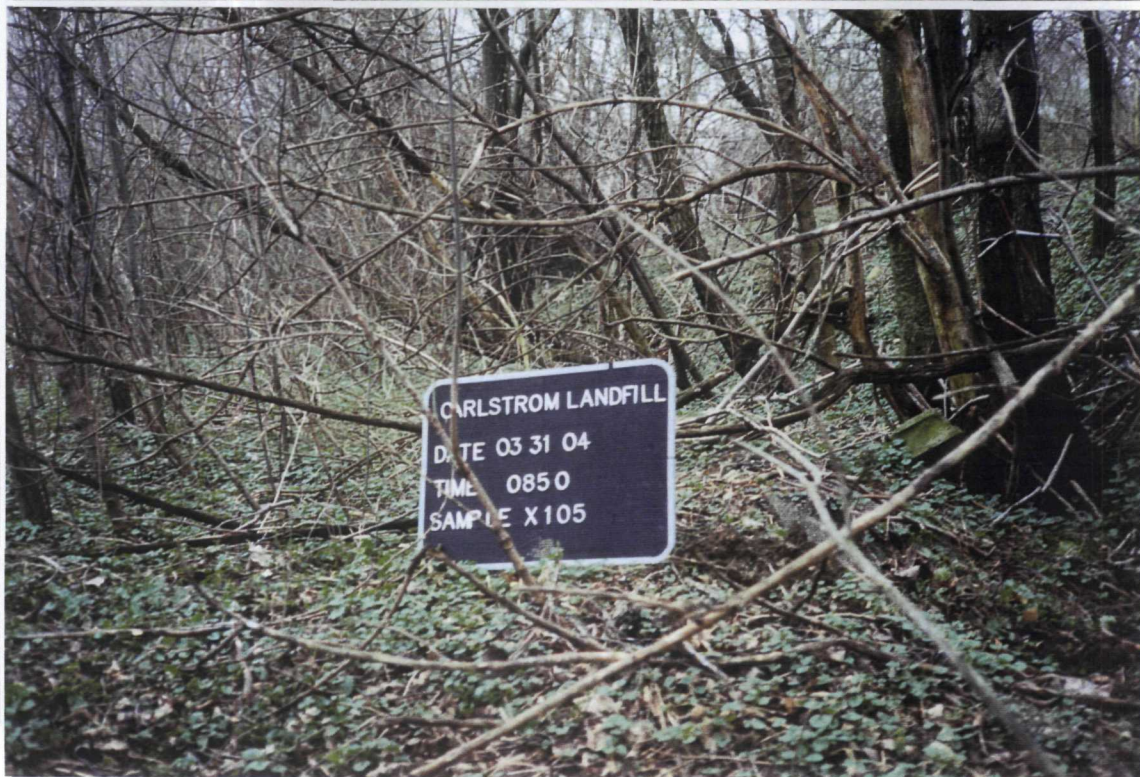
DATE: 3/31/04
TIME: 8:50
PHOTOGRAPH TAKEN BY: R. CASPER
COMMENTS: Picture taken toward: West.
Photo Number 18.
Sample X105. The sample was collect- ed at a depth of 3" to 4" in a small ravine.

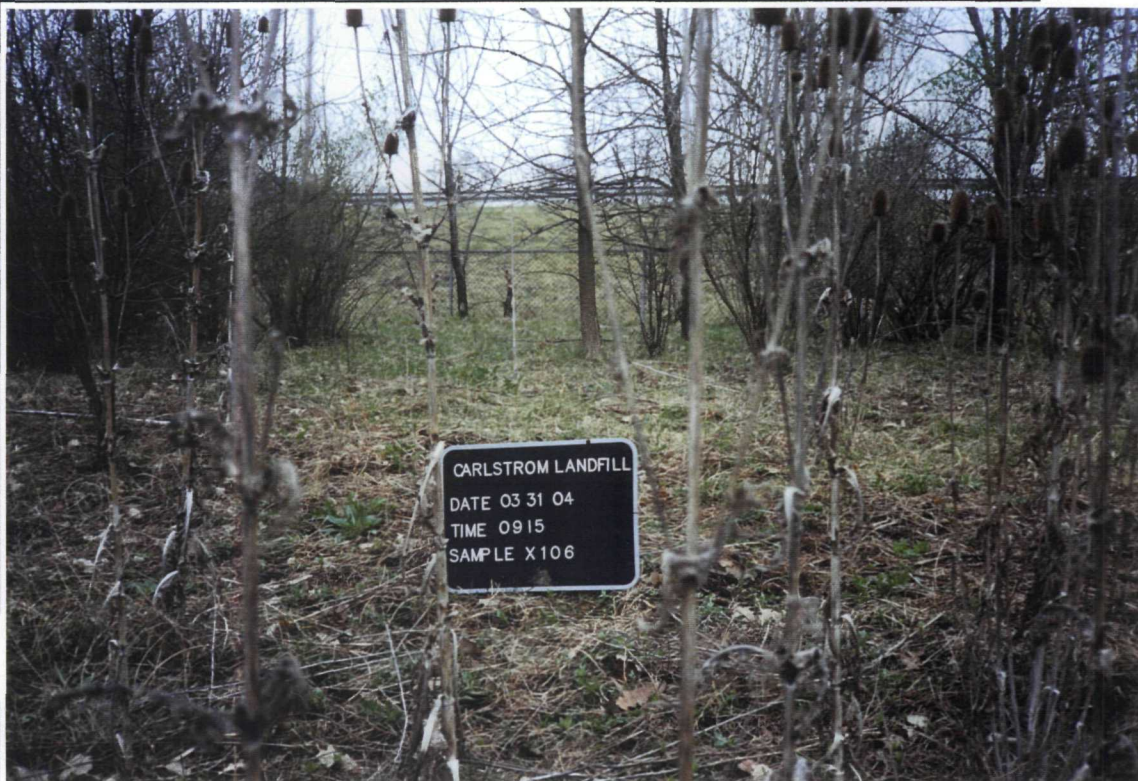
DATE: 3/31/04	SITE IL# #: 980497721	COUNTY: Will
TIME: 9:15	SITE NAME: Carlstrom Landfill	
PHOTOGRAPH TAKEN BY: R. Casper		
COMMENTS: Picture taken toward: North.		
Photo Number 19.		
Sample X106 was collected at the northern portion of the landfill near the I-80 ramp.

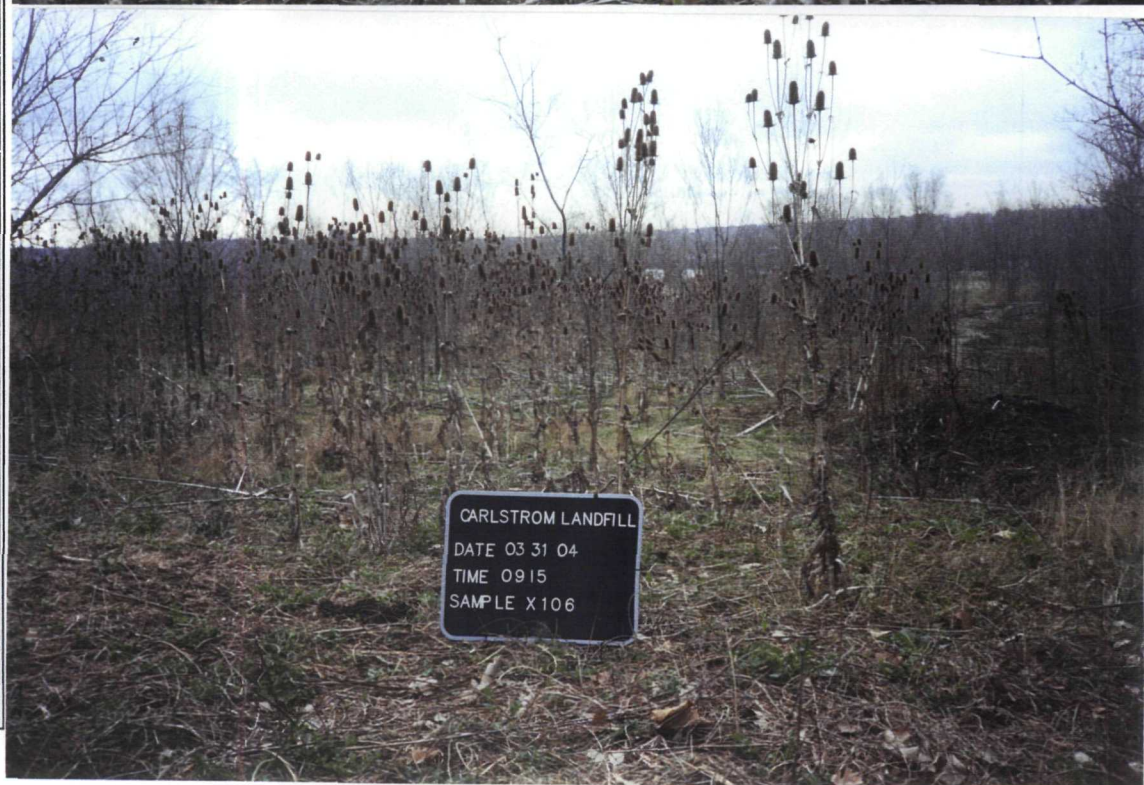
DATE: 3/31/04
TIME: 9:15
PHOTOGRAPH TAKEN BY: R. CASPER
COMMENTS: Picture taken toward: South.
Photo Number 20.
Sample X106. The sample was collected at a depth of 1" to 3".

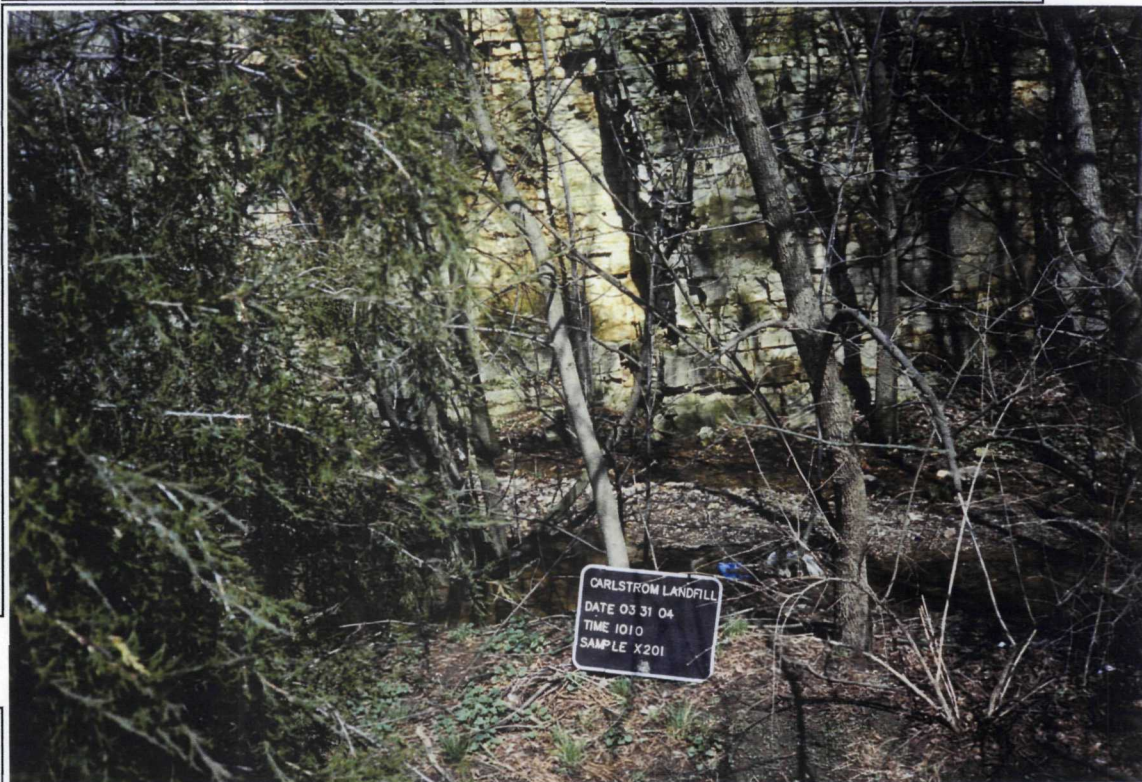
PHOTOGRAPH TAKEN BY: R. Casper
COMMENTS: Picture taken toward: North.
Photo Number 21.
Sample X201 was collected at the north side. Part of quarry rock face is in background.

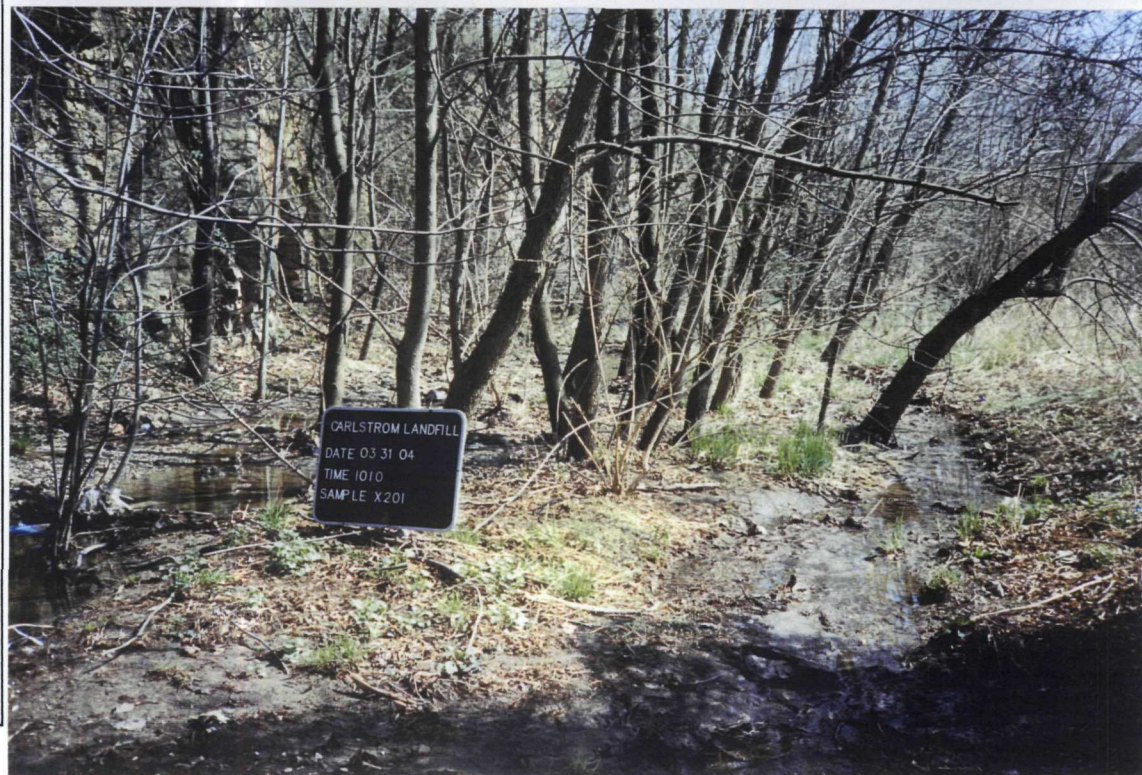
DATE: 3/31/04
TIME: 10:10
PHOTOGRAPH TAKEN BY: R. CASPER
COMMENTS: Picture taken toward: East.
Photo Number 22.
Sample X201. The runoff from the I-80 access ramp flows around a portion of the landfill.

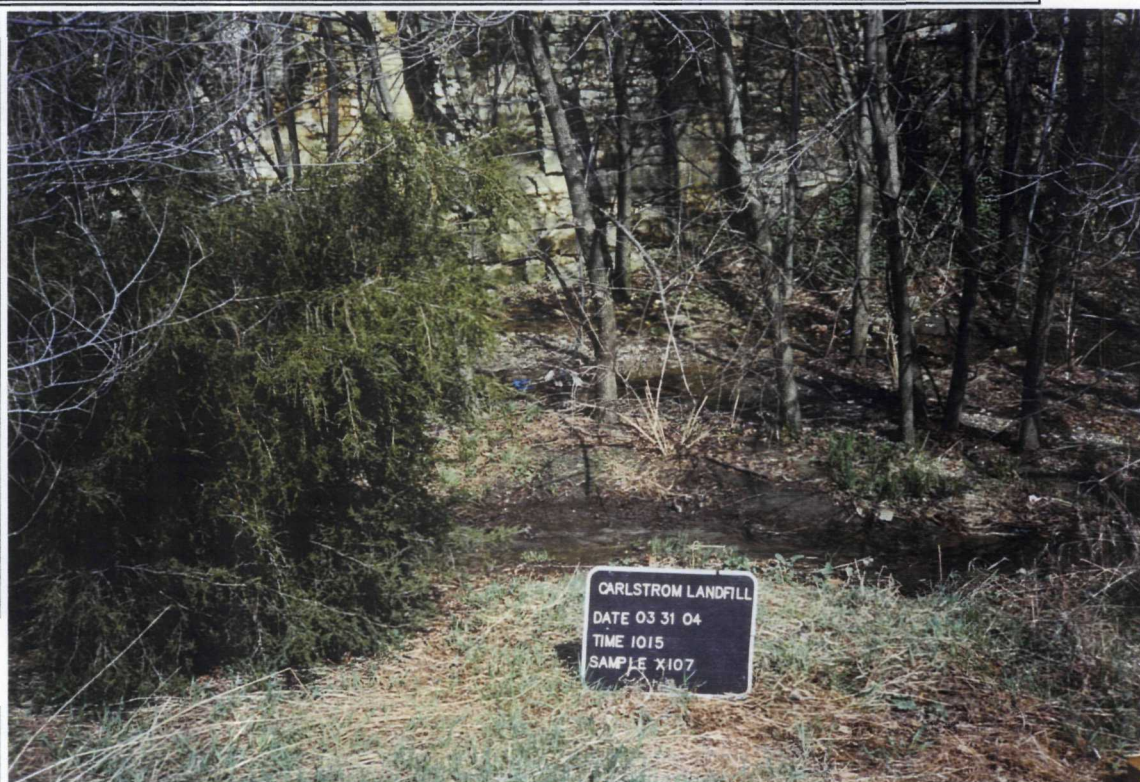
PHOTOGRAPH TAKEN BY: R. Casper
COMMENTS: Picture taken toward: North.
Photo Number 23.
Sample X107 was collected near sediment background sample X201. Rock face in background.

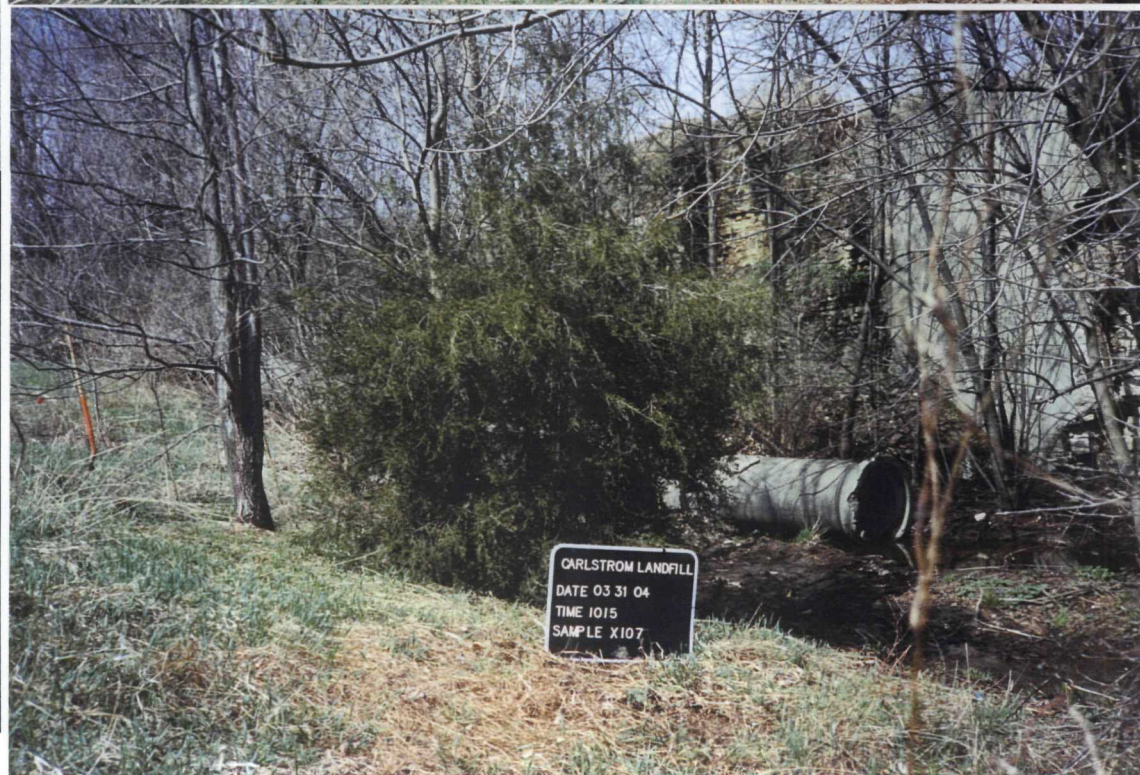
DATE: 3/31/04
TIME: 10:15
PHOTOGRAPH TAKEN BY: R. CASPER
COMMENTS: Picture taken toward: West.
Photo Number 24.
Sample X107. The rock face is at the right. A part of the broken I-80 drainage pipe is visible at bottom.
